2017 EBRIGHT CREEK BIOLOGICAL AND WATER QUALITY MONITORING REPORT (YEAR 3)

PREPARED FOR:
THE CITY OF SAMMAMISH
801 228th Ave SE
Sammamish, Washington 98075

Prepared by
48north
solutions

December 20, 2017

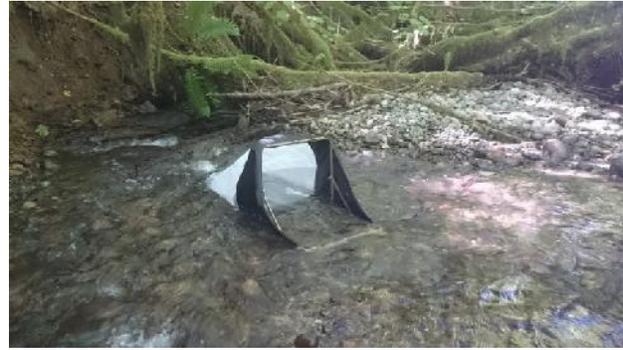
Photo 1: Suber Net Set-up

A 930-square cm (1-square foot [sq. ft.]) Surber net, with 500 µm mesh, was used to collect macroinvertebrates, starting at the lowest (downstream) sample site and working upstream (Photo 1). The Surber net is a 30 cm by 30 cm (12 x 12-inch) frame that is horizontally placed into the face of the flow on gravel/cobble substrate to delineate a 930-square cm (1 sq. ft.) area. The vertical section of the frame has a net attached and captures any dislodged organisms from the sampling area. A total of 0.74 m² (8 sq. ft.) were sampled at each location following the methods of Hayslip (2007).

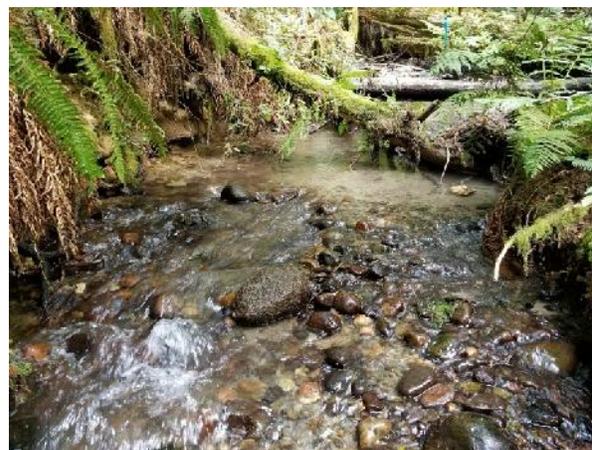
Photo 2: Typical Stream Substrates Observed in Reaches 6 and 7

Substrate composition is a useful indicator to describe how a channel stores and transports sediment. All measures of substrate were taken at transects every 25 m (82 feet) within representative reaches. The most common substrates in Reach 0 were coarse gravels, interspersed with some cobble and fine gravel typical of higher gradient streams (Figure 4). Substrate in Reach 1 was finer than Reach 0. Reaches 2, 3, 4, and 5 were located in a second growth forest where riparian vegetation provided channel stability. The stream bed in these reaches contained less fine gravels than the other reaches and the substrate coarseness increased progressively upstream (Figure 4). Reaches 6 and 7 were dominated by coarse gravels, cobbles, and boulders with fines (Photo 2). Reach 8 was

dominated by fines and gravels that are typical of lower gradient reaches. An increase in finer sediment input in Reaches 5 to 7 was observed in 2017, possibly due to mobilization of substrates from upstream sources. These fine sediments in these reaches maybe the result of erosion from landslides upstream. These landslides may have increased the rate of fine sediment and gravel recruitment into these reaches, causing the stream channel to expand in a manner similar to an alluvial fan. The steep ravines of the canyon reaches are located within an erosion hazard area and are prone to landslides. The landslides then act as a feeder source for gravels and fines that are then transported downstream during high flow events.

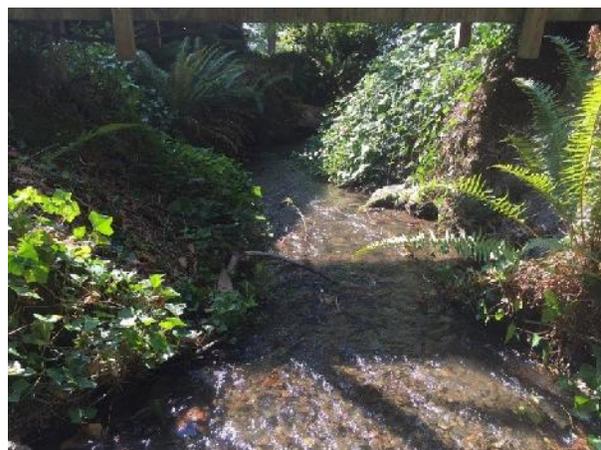
Photo 3: Typical Ground Cover and Riparian Habitat along Reach 0

Overall, the riparian buffers appear to be functioning properly and the stream channel is generally stable. Riparian vegetation provides important shade for the stream, a source of recruitment for wood, and reduced rates of erosion. The riparian condition observed in Reaches 0 and 1 was mostly restored mixed deciduous forest, shrubs, and invasive species with lawns, driveways and residential areas adjacent to the narrow stream riparian corridor. Reach 0 was located in a steeper ravine with a limited number of second growth coniferous trees present in the riparian zone (Photo 3). Riparian condition from Reaches 2 to 6 consisted of second growth mixed forest of big leaf maple (*Acer macrophyllum*), cedar, and Douglas fir (*Pseudotsuga menziesii*) with a fairly closed canopy (Photo 4). Riparian conditions in Reaches 7 and 8 consisted of a second growth forest in a steep ravine, but the canopy was comprised of

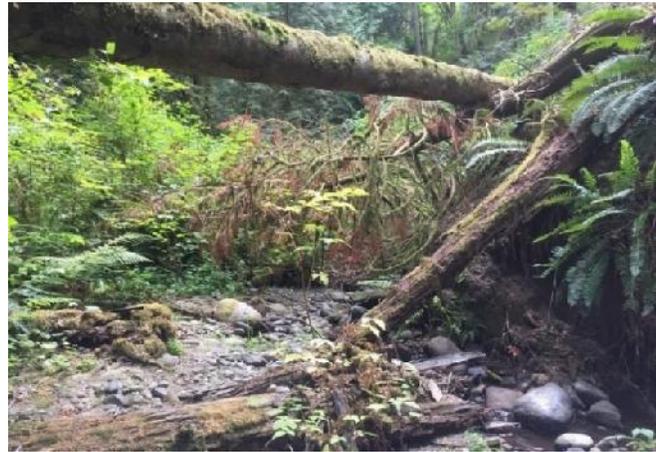
Photo 5: Landslide in Reach 8 Showing an Unstable Left Bank

tall shrubs and small trees (e.g., salmonberry [*Rubus spectabilis*]) due to disturbance regime caused by landslides (Photo 5).

Several landslides were observed adjacent to Ebright Creek along Reaches 6 to 8 (Photo 5) in 2015. There were several more landslides observed in 2017 compared to 2015 along these same reaches. These landslides contributed significant amounts of material to the stream bed. Bank stability was measured at the Reach level using the method described by Booth (1994). Reaches 0 and 1 were armored with rip-rap in many sections of these two reaches (Photo 3). Reaches 2 to 6 were stable and had vegetated and barren gravel bars interspersed within the active stream channel (Photo 4). Reaches 7 and 8 were unstable and showed imminent signs of erosion, such as sluffed banks and fallen trees (Photos 5 and 6) during 2015 baseline surveys. Riparian areas along Reaches 7 and 8 were unstable during 2017 surveys, and channel migration was observed. Also, more invasive and pioneering plant species, such as reed canary grass and Himalayan blackberry (*Rubus armeniacus*), were observed in areas impacted by landslides along Reaches 6 to 8. Channel widening along these reaches were also likely due to bank instability (erosion), typically resulting in larger width to depth ratios (Photo 6). In addition, channels that are simplified and lacking in deep pools also have a larger width to depth ratio.

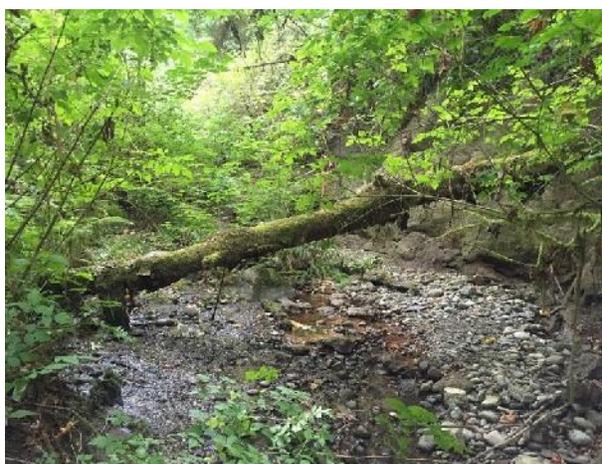
Photo 6: Typical Wide Stream Channel Observed in Reaches 7 and 8

This may be attributed to the increase in the number of landslides in the upper reaches since 2015. The number of pools and LWD observed in Year 3 (2017) increased significantly in Reach 7 compared to Year 1 (2015). This increase in number of pools may be attributed to the change in stream course, gradient, and/or amount of LWD in the stream channel.
