EBRIGHT CREEK BIOLOGICAL AND WATER QUALITY MONITORING BASELINE REPORT

PREPARED FOR:
THE CITY OF SAMMAMISH
801 228th Ave SE
Sammamish, Washington 98075

Prepared by
48north
solutions

December 15, 2015

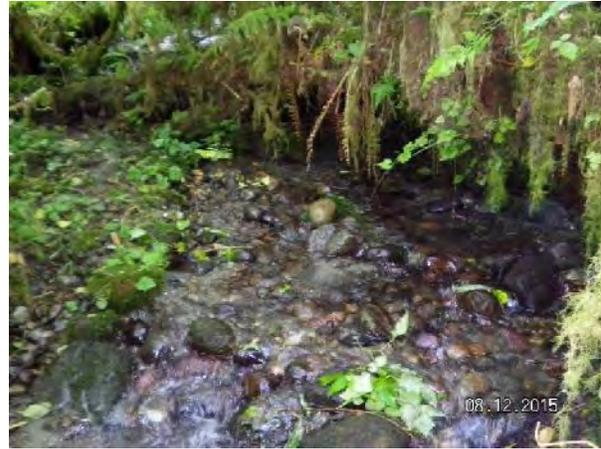
Photo 2: Typical Stream Substrates Observed in Reaches 4 to 6

Substrate composition is a useful indicator to describe how a channel stores and transports sediment. All measures of substrate were taken at transects every 25 m (82 feet) within representative reaches. The most common substrates in Reach 0 were coarse gravels, interspersed with some cobble and fine gravel typical of higher gradient streams (Figure 4). Substrate in Reach 1 was finer than Reach 0. Reaches 2, 3, 4 and 5 were located in a second growth forest where riparian vegetation provided channel stability. The stream bed in these reaches contained less fine gravels than the other reaches and the substrate coarseness increased progressively upstream (Figure 4). Reaches 6 and 7 were dominated by coarse gravels, cobbles,

and boulders with fines (Photo 2). Reach 8 was dominated by fines and gravels that are typical of lower gradient reaches. These fine sediments are probably the result of erosion in this reach from landslides, which increases the rate of fine sediment and gravel recruitment into this stream reach and causes the stream channel to expand in a manner similar to an alluvial fan. The steep ravines of the canyon reaches are located within an erosion hazard area and are prone to landslides.

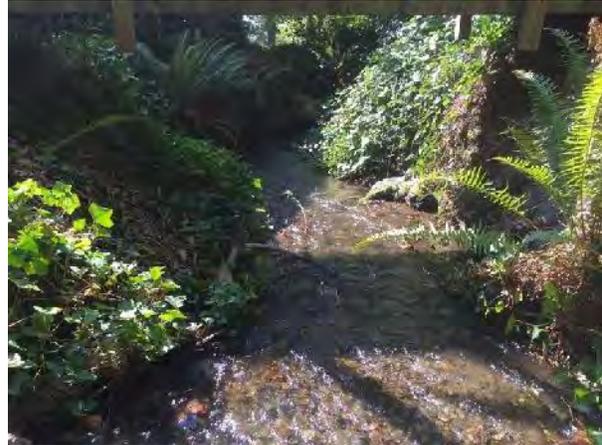
Photo 3: Typical Ground Cover and Riparian Habitat along Reach 0

Overall, the riparian buffers appear to be functioning properly and the stream channel is generally stable. Riparian vegetation provides important shade for the stream, a source of recruitment for wood, and reduced rates of erosion. The riparian condition in Reaches 0 and 1 was mostly restored mixed deciduous forest, shrubs, and invasive species with lawns, driveways and residential areas adjacent to the narrow stream riparian corridor. Reach 0 was located in a steeper ravine with a limited number of second growth

coniferous trees present in the riparian zone (Photo 3). Riparian condition from Reaches 2 to 6 consisted of second growth mixed forest of big leaf maple (*Acer macrophyllum*), cedar, and Douglas fir (*Pseudotsuga menziesii*) with a fairly closed canopy (Photo 4). Riparian conditions in Reaches 7 and 8 consisted of a second growth forest in a steep ravine, but the canopy was comprised of tall shrubs and small trees (e.g., salmonberry [*Rubus spectabilis*]) due to disturbance regime caused by landslides (Photo 5).

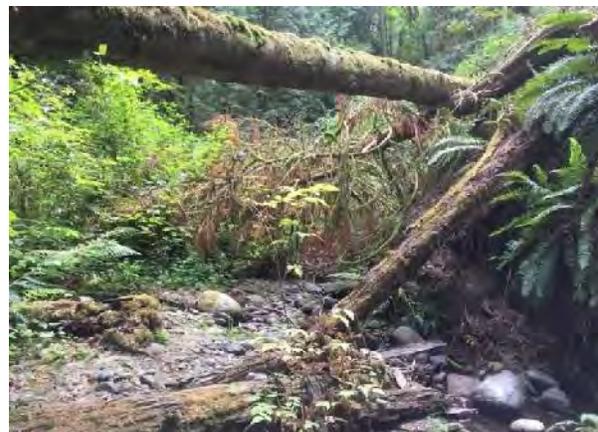
Photo 5: Landslide in Reach 8 Showing an Unstable Left Bank

Several landslides were observed adjacent to Ebright Creek along Reaches 6 to 8 (Photo 5). These landslides contributed significant amounts of material to the stream bed. Bank stability was measured at the Reach level using the method described by Booth (1994). Reaches 0 and 1 were armored with rip-rap in many sections of these two reaches (Photo 3). Reaches 2 to 6 were stable and had vegetated or low bars to level of low flow (Photo 4). Reaches 7 and 8 were unstable and showed imminent signs of erosion such as sluffed banks or fallen trees (Photos 5 and 6). Channel widening along these reaches were also likely due to bank instability (erosion), typically resulting in width to depth ratios that are larger than 10:1 (Photo 6). In addition, channels that are simplified and lacking in deep pools also have a larger width to depth ratio.

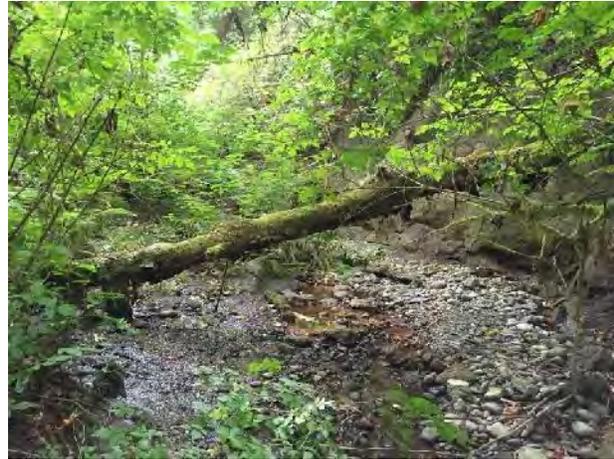
Photo 6: Typical Wide Stream Channel Observed in Reaches 7 and 8

Pools are important habitats for stream fish and macroinvertebrates. Pools are often formed by pieces of LWD. The PFC criteria for streams supporting salmonids has a minimum criteria of 150 pieces of LWD per km (NMFS, 1996), which were met in this stream. NMFS' (1996) PFC criteria for pool frequency is greater than 35 pools per km. It is surprising that pool frequency is high and LWD is only marginal in Reach 5 but that may be attributed to the steep nature of that reach and the fact that many of those pools are small cascade pools formed by cobble and boulders rather than LWD (Figures 7 and 8).
